# melett

## OIL CONTAMINATION

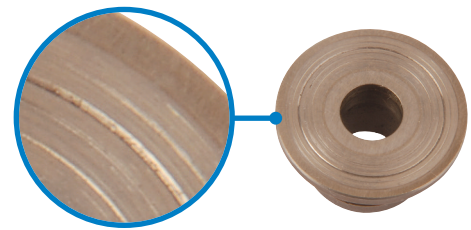
Scoring to thrust parts

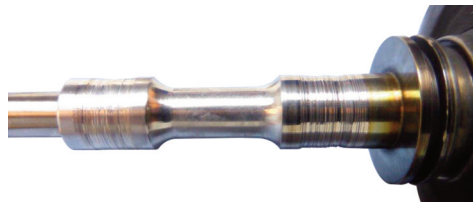
Scoring to journal bearing diameter on shaft & wheel

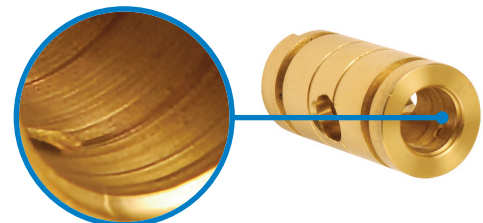
Scoring to journal bearings
