melett

OVERSPEEDING

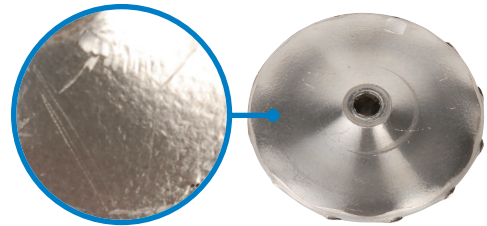
- Engine modifications including 'chipping' or 'over-fuelling'
- Inconsistent flow of air into the turbo;
 - Tear in the air hose or the hose becoming completely detached
 - Restrictions in the air intake filter or pipe work
 - Air leaks between compressor and engine
- The wastegate or VNT mechanism has been set incorrectly
- Worn injectors
- Installing an incorrect turbo
- Loss of signal to the Electronic Actuator for the wastegate or VNT control
- High altitude
- Incorrect movement or restrictions in the VNT mechanism

- The 'orange peel' effect
- Inducer blade damage
- Partial loss of blades
- Burst wheel
- Fatigue fractures of blades

'Orange peel' effect on compressor wheels

- The turbocharger must always be left in the original state
- The turbocharger may only be installed in the specified vehicles
- Check there are no restrictions or leaks in the air intake pipe work
- Ensure the wastegate or VNT linkage is operating freely and is properly calibrated
- Check the electronic sensors and ECU are operating correctly
- Avoid remaps chipping or over-fuelling

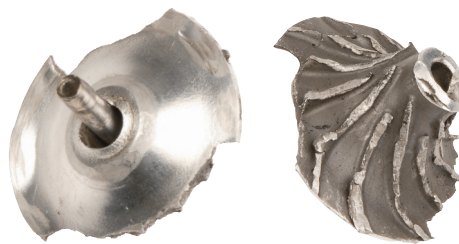
Complete component failure

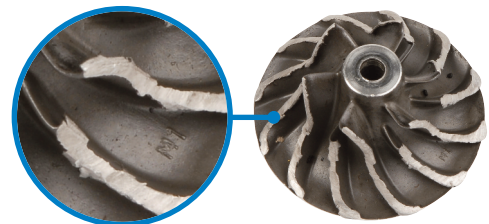
Compressor wheel rub
